REFERENCE REACH FIELD FORM
STREAM CHANNEL CLASSIFICATION LEVEL II

STREAM NAME: Black Creek DRAINAGE AREA: 169 square miles BASIN NAME: Genesee

OBSERVERS: J. Hauber, F. Reese DATE: 10/7/2004

BLACK CREEK - CHILI SITES (CI-1, CI-2)
STREAM RESTORATION STUDY AREAS

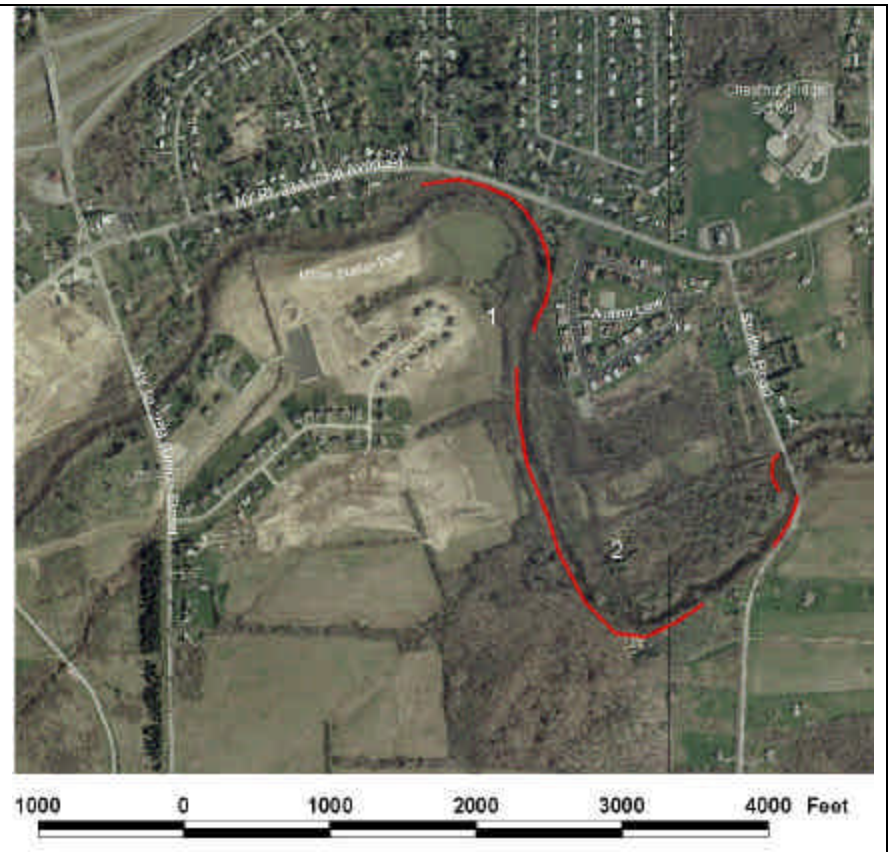
CI-1 and CI-2, Aerial Photo Detail (2002)

Three tributaries form confluences with Black Creek within the study reach. One tributary flows into the creek from the south approximately 1500 feet east of Union Street. An intermittent drainage ditch flows into the creek from the north at the point where Chili Avenue is closest to the creek. A second intermittent tributary forms a confluence on the south side of the creek, south of a new housing tract. A third intermittent tributary joins Black Creek just west of the Stottle Road bridge. Some bank erosion was noted near these confluence points. Banks are generally stable where scour has not created high banks on the outside edges of meanders. High banks with exposed soils are subject to scour during high flow conditions. These areas are indicated in red on the photograph above.

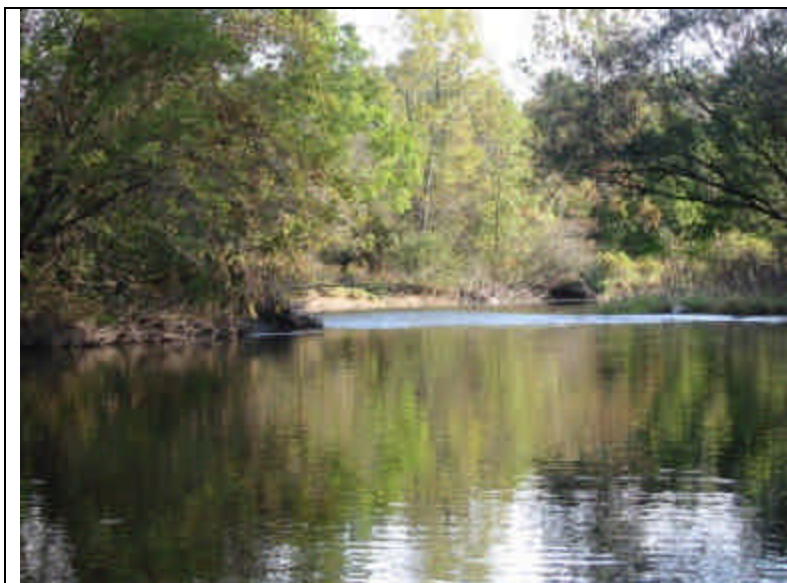
<p>Exposed high banks on outside edge of meander, near Chili Avenue.</p>	<p>Undercut root systems of sugar maples, south bank of Black Creek, Union Station Park, Chili</p>

5. Embed large stone rip rap in the scoured areas adjacent to vulnerable roadways and repair the embankment using vegetated geogrids, root wads, and willow stakes.

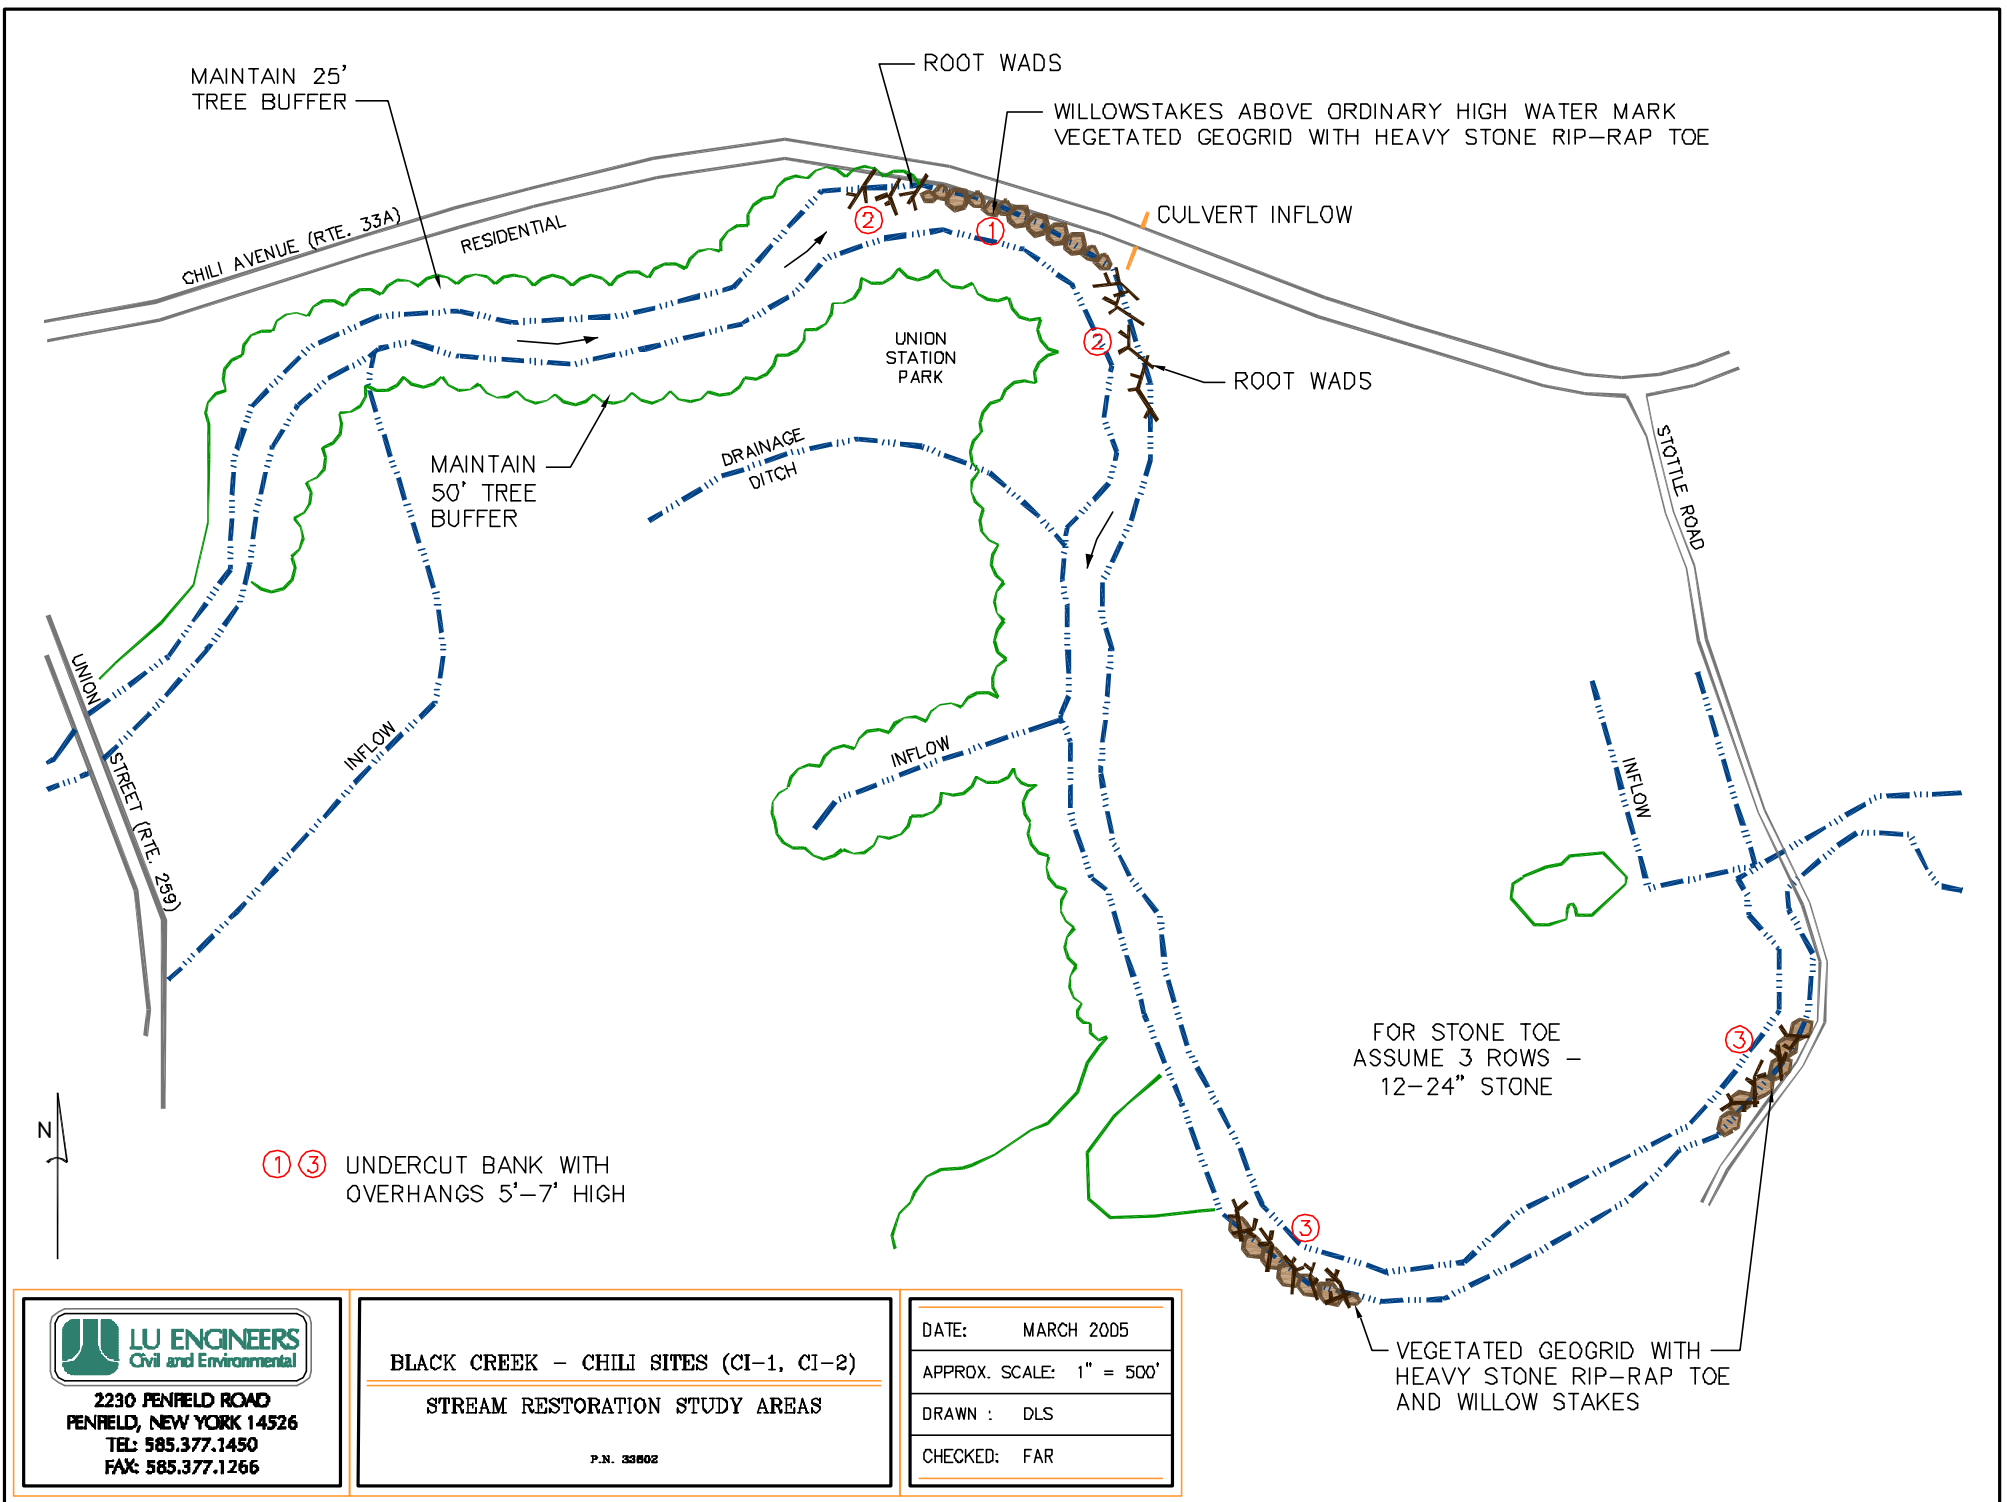
① ③ UNDERCUT BANK WITH
OVERHANGS 5'-7' HIGH

MAINTAIN 25'
TREE BUFFER

ROOT WADS

WILLOWSTAKES ABOVE ORDINARY HIGH WATER MARK
VEGETATED GEOGRID WITH HEAVY STONE RIP-RAP TOE

MAINTAIN
50' TREE
BUFFER

FOR STONE TOE
ASSUME 3 ROWS -
12-24" STONE

VEGETATED GEOGRID WITH
HEAVY STONE RIP-RAP TOE
AND WILLOW STAKES
