REFERENCE REACH FIELD FORM
STREAM CHANNEL CLASSIFICATION LEVEL II

STREAM NAME: Black Creek DRAINAGE AREA: 27.8 sq. miles BASIN NAME: Genesee River

LOCATION: Black Creek at Griswold Road, Town of Byron, Genesee County, Sites B42 and B43 Latitude 43-02-03 Longitude 78-04-33

BLACK CREEK AT GRISWOLD ROAD
TOWN OF BYRON, GENESEE COUNTY
CONCEPTUAL DESIGN

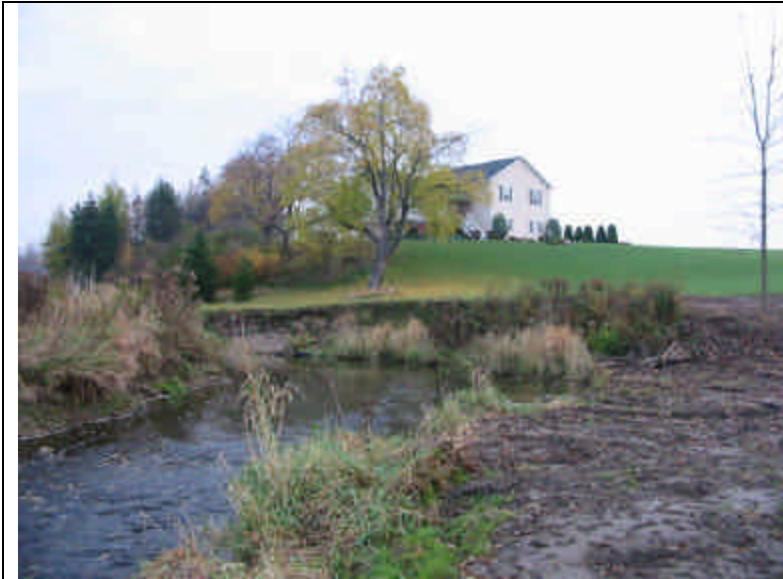
Photo 1. View of project site showing exposed soil on high, undercut bank at outside edge of meander, near Station 4+00, looking northeasterly. Bare soil at photo right is due to mechanical vegetation clearing.

1. Re-establish shrubs and trees along channel banks to at least 30 feet from the top of bank.
2. Establish a “no-mow” zone within 30 feet of channel top of bank.
3. Place riprap (12-24 in. diameter rock) at base of highest eroding meander bank on east side of creek from approximately Station 3+00 to Station 4+90, and on the west side of the creek from approximately Station 2+00 to 3+00 to reduce undercutting by channel currents and high flows.
4. Embed available on-site downed timber as rootwads on the west bank between Station 2+00 and Station 3+00 (approximately). Root wads should deflect current away from outside edge of bank.
5. Utilize willow logs on west bank between Station 4+68 and Station 6+34 to stabilize this slumping bank.
6. Construct three rock cross vanes to hold the channel grade approximately at Stations 1+90, 3+10, and 7+00.

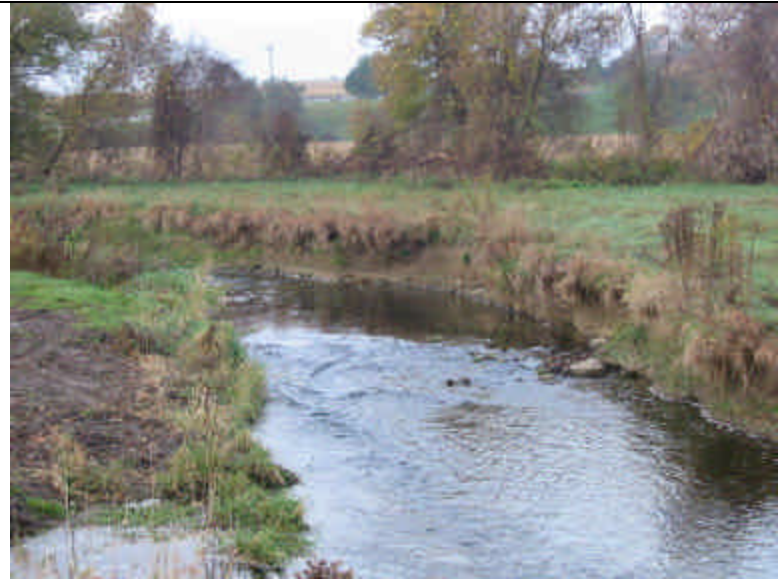
Photo 2. View of exposed soil along west bank of creek at Station 2+10, looking south. Bank height is approximately 2-2.5 feet above water level.

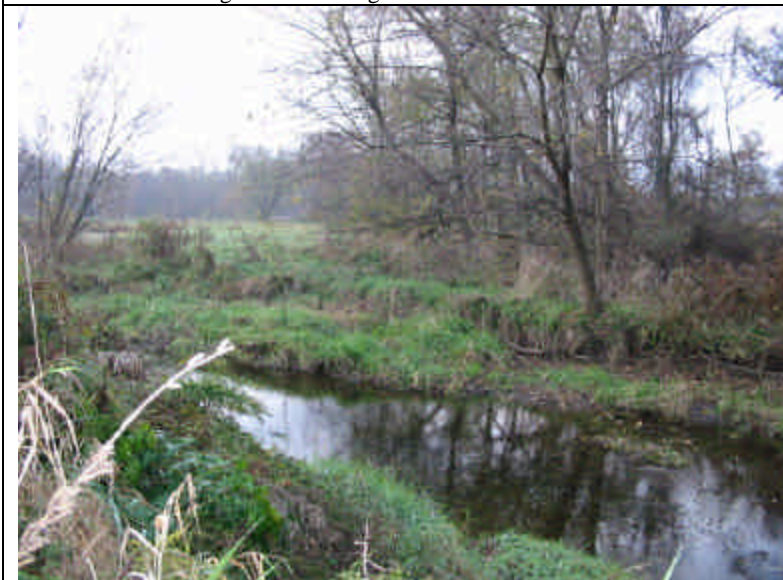
Photo 3. Frequent bankfull flows have caused sloughing of west bank into formerly stable section of stream channel, causing formation of mid-channel bars. Diversion of current around the mid-channel bars contributes to bank undercutting and instability.

Statement of Problem: The stream channel appears to be downcutting actively at this site. Bank sloughing evident in Photo 3, exposed tree roots, and scoured, undercut outside meander banks all point to a channel in transition. Increased frequency of bankfull flows may contribute to the accelerated rate of channel degradation. Removal of woody vegetation from the top of bank on the east side of the channel has resulted in an accelerated rate of undercutting and bank erosion due to the loss of stabilizing plant roots. Channel currents are undercutting the east bank, causing significant soil erosion and increased channel deposition. Undercutting on the east side of the creek is creating a significant erosion hazard, and loss of property by adjacent landowner.

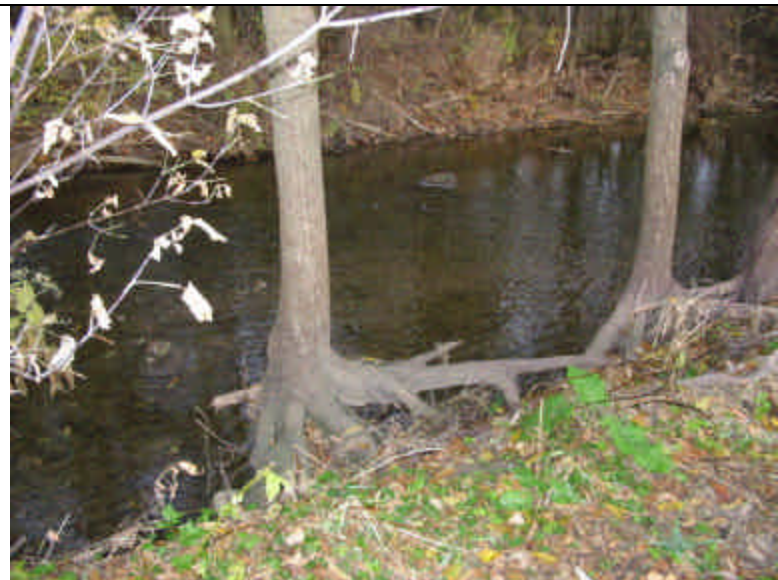
Photo 4. Scouring and undercutting have exposed root systems of numerous trees lining the stream channel.
