REFERENCE REACH FIELD FORM
STREAM CHANNEL CLASSIFICATION LEVEL II

STREAM NAME: <u>Oatka Creek</u>	DRAINAGE AREA: <u>200 square miles</u>	BASIN NAME: <u>Oatka</u>	
OBSERVERS: <u>F. Reese</u>		DATE: <u>11/16/2004</u>	
LOCATION: <u>Oatka Creek, one-half mile east of Union Street bridge, Town of Wheatland, Monroe County</u>		Latitude <u>43°00'25"</u> Longitude <u>77 ° 47'03"</u>	
		Type(s) <u>Wampsville K cobble loam Factor 0.20 K Eel silt loam Factor 0.43 Genesee silt K loam Factor 0.43</u>

OATKA CREEK AT 1198 QUAKER ROAD
CONCEPTUAL DESIGN

STREAM RESTORATION STUDY AREAS

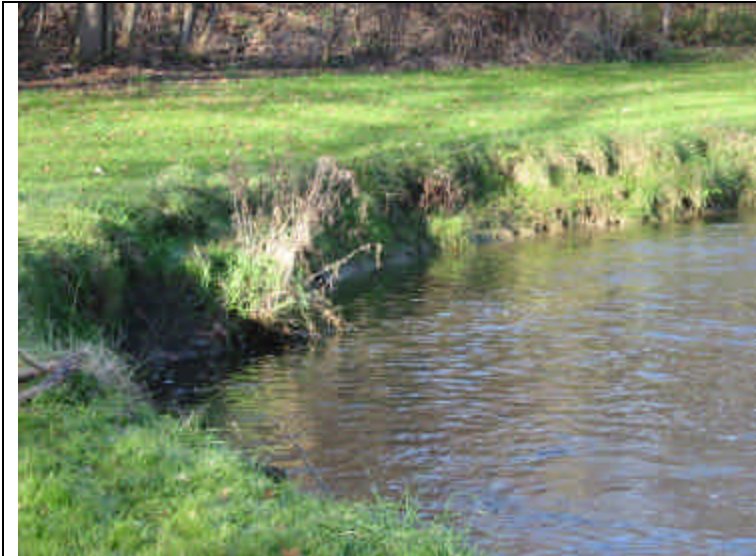
Erosion on south bank of Oatka Creek at 1198 Quaker Road. Note slumping from undercutting of clay bank.

1. Establish a 25-50 ft. "no-mow" zone adjacent to the creek
2. Remove existing in-stream obstructions (logs, stones, etc.) directing current toward scoured bank.
3. Plant willows, dogwoods, and cottonwoods to re-establish riparian vegetation on the south side of the creek.
4. Construct a rock J-vane (stream barb) upstream of the scour zone to re-direct flow into the main channel.
5. Embed approximately 175 feet of stone riprap, and on-site rootwads at the toe of the scoured bank. Backfill to 1:2 slope and stabilize with willow stakes. Plant top of bank with dogwood and cottonwood to match existing riparian vegetation.

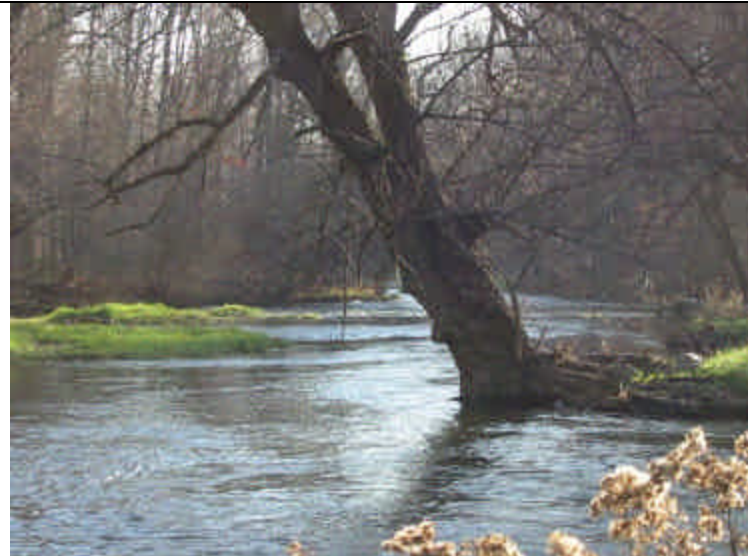
Single remaining black willow tree holds bank in place. Root system is completely exposed.

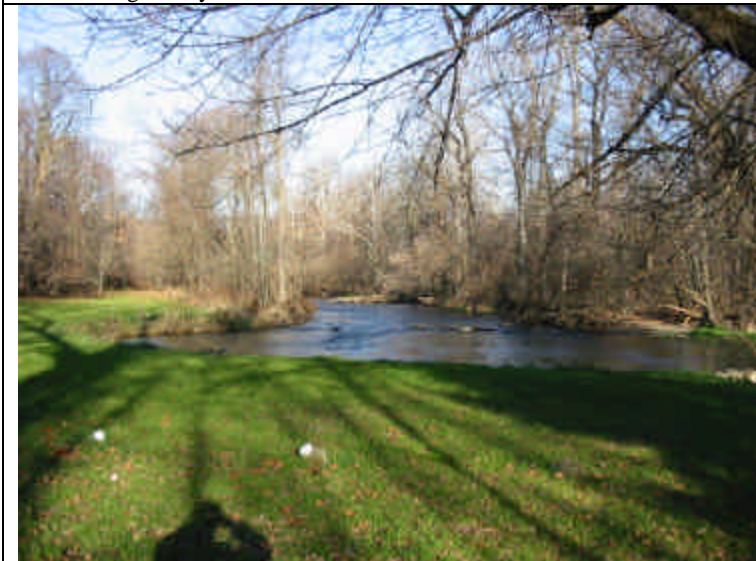
View of south bank of Oatka Creek, looking west (upstream) from leaning willow tree in photo above. Current has scoured a large indentation in the south bank.

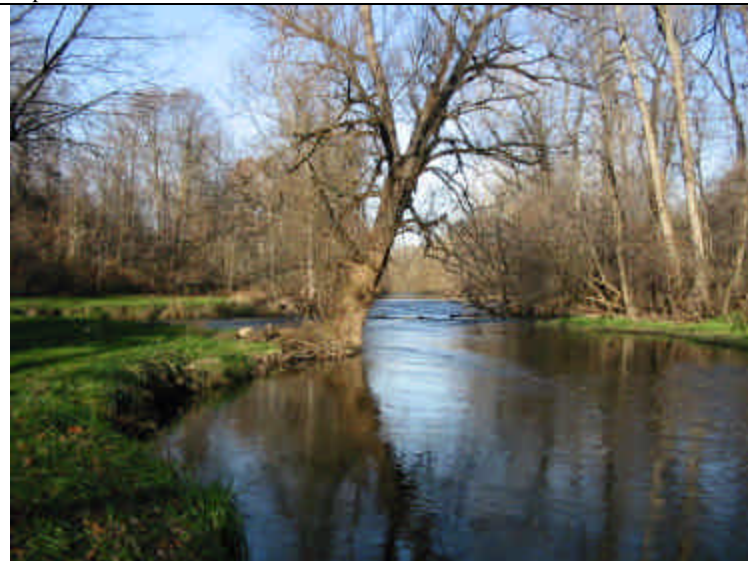
View of exposed willow tree and mowed bank looking upstream.

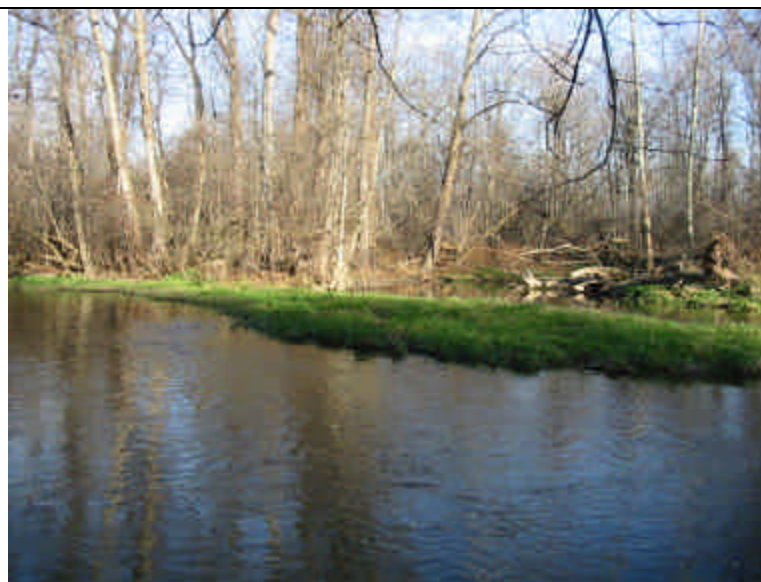
View of mid-channel island in Oatka Creek, opposite scour hole.
