REFERENCE REACH FIELD FORM
STREAM CHANNEL CLASSIFICATION LEVEL II

Oatka Creek Site E-037, at Rochester & Southern Railroad Bridge, Town of LeRoy, Genesee County

SITE E-37, LEROY
 STREAM RESTORATION STUDY AREAS

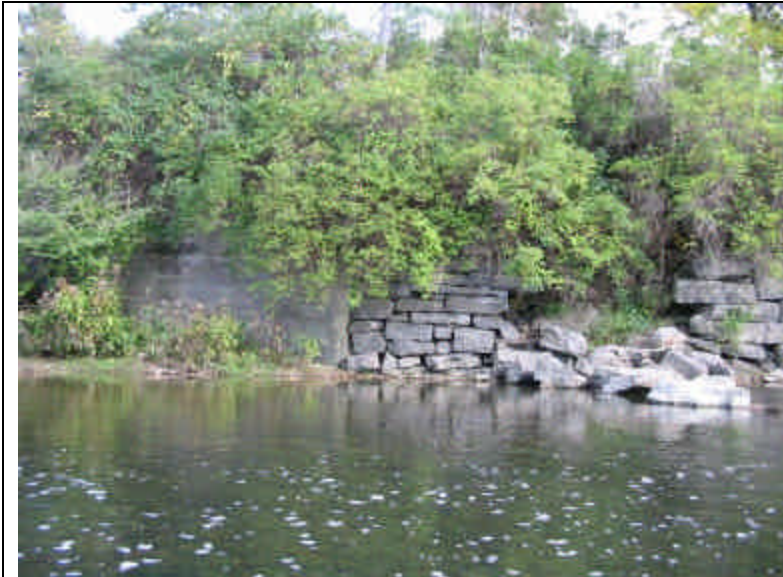
Failing retaining wall at southwest quadrant of Rochester & Southern Railroad bridge over Oatka Creek

2. Inspection of the southwest quadrant of the bridge showed that a stone retaining wall has partially collapsed into the creek. Further evaluation is needed to determine an appropriate repair strategy before the entire embankment fails.

- Install a rock J-vane upstream of the northwest abutment to direct current away from the structure into the main channel of the Oatka.
- Install a rock J-vane upstream of the southwest abutment to direct current away from the failing retaining wall.
- Contact the railroad to advise them of the failing retaining wall.

Costs for construction of a J-vane to redirect water away from the failing retaining wall were not estimated due to complicated access issues. Further review by the railroad is needed to address this issue.

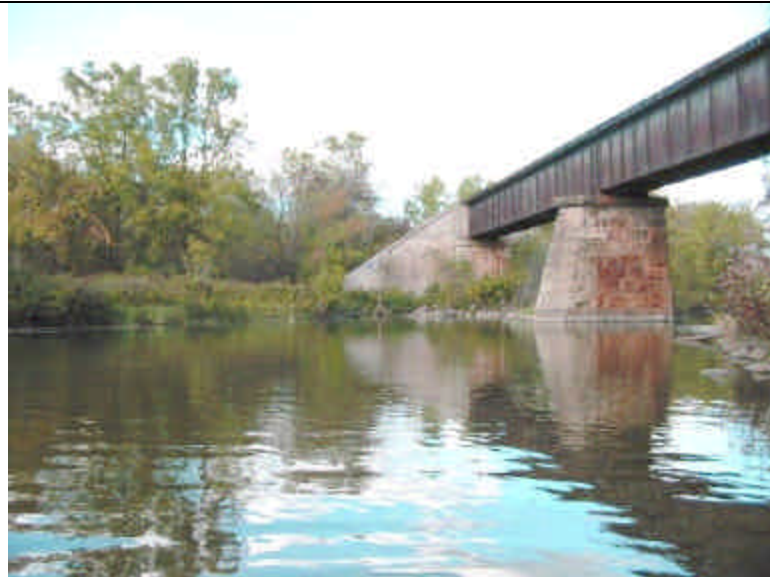
View of northwest quadrant of bridge. Current hits abutment at near right angle, creating scour hole at northwest quadrant.

1. A large scour hole has developed at the northwest quadrant of the Rochester & Southern Railroad bridge. Channel flow hits the bridge abutment at a near right angle, creating an eddy, which has scoured a deep hole in the channel substrate. Further evaluation may be required to determine if this scour hole has affected the bridge substructure.

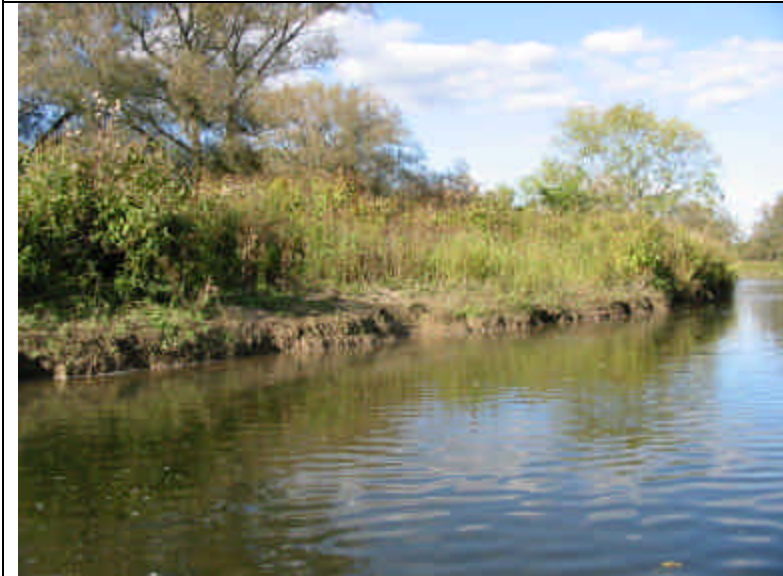
West/north bank of Oatka Creek near railroad bridge (typical). Note exposed soil in scour areas.
