REFERENCE REACH FIELD FORM
STREAM CHANNEL CLASSIFICATION LEVEL II

STREAM NAME: Oatka Creek DRAINAGE AREA: 135 sq. miles ± BASIN NAME: Oatka

LOCATION: Oatka Creek between Munson Street and Rt. 5 dams, Village of LeRoy, Genesee County

OATKA CREEK AT VILLAGE OF LEROY
CONCEPTUAL DESIGN

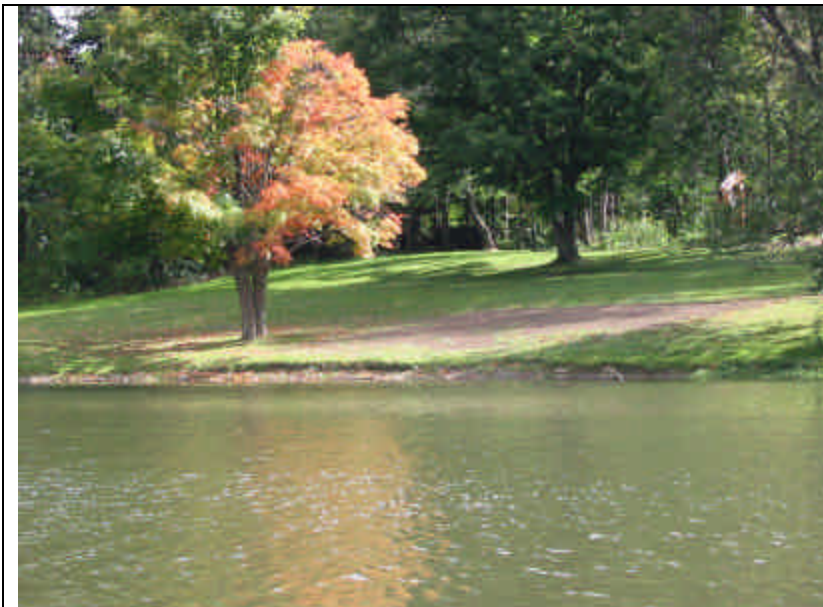
Photo 1. Eroded bank conditions typical of south side of Oatka Creek, immediately east of Rt. 19 bridge

Statement of Problem: The south bank experiences severe erosion and undercutting due to fluctuating water levels and currents driven by the prevailing winds between the Rt. 19 bridge and the Rt. 5 bridge. The bank is mowed to the top of the bank in this reach. Visual observation showed that the bank has slumped about 2-4 feet into the creek. The Village reportedly is planning to install more heavy stone riprap along the south bank to protect the shoreline. Where a fringe of riparian marsh type vegetation exists, the bank is better protected.

- Establish a 25-50 ft. wide "no mow" zone along south creek bank between the Route 5 dam and the Route 19 bridge with scattered clear areas to maintain the view of the creek. The longer grass along the shoreline will discourage the influx of Canada geese.
- Place riprap out from south bank shoreline approximately 5 feet and backfill with approximately 1-2 feet of soil material as a bed for emergent aquatic vegetation.

- Plant native species such as giant bur-reed (*Sparganium eurycarpum*, *Scirpus atrovirens*, *Scirpus validus*) in shallow water areas along the bank behind the rock wall to reduce the impact of waves and currents. [Note: a side benefit of planting tall emergents such as giant bur-reed is that it discourages Canada geese from landing on the water and wading out onto the shoreline).
- Plant groupings of red maple, willow, and dogwood along the shoreline close to the top of the bank to re-establish woody vegetation.
- Offer a public education/outreach program on do-it-yourself streambank protection techniques for homeowners. Encourage the use of vegetative measures to control erosion.

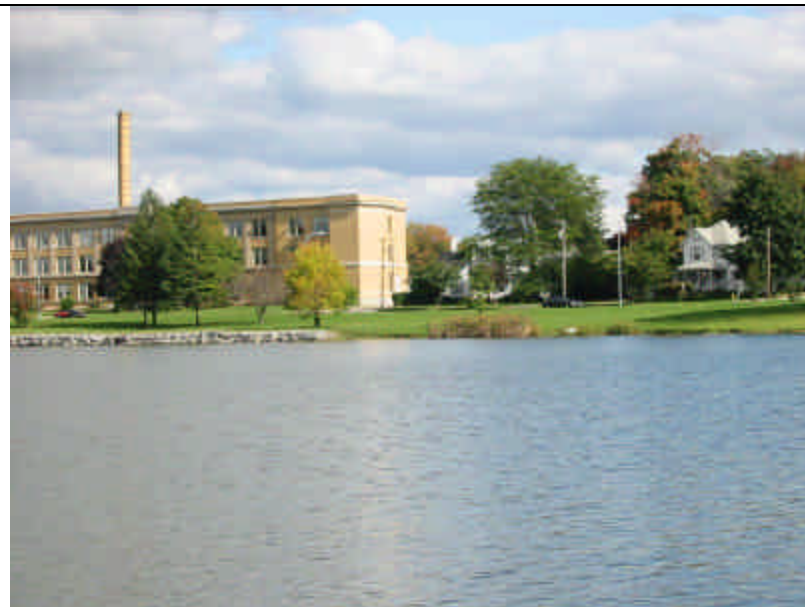
Photo 2. View of south bank of Oatka Creek, with Wolcott Street in the background. Note partial stone riprap along bank at photo left, and growth of riparian vegetation (bur-reed) at photo center.

The Village of LeRoy maintains a sanitary sewer main adjacent to the creek channel parallel to Wolcott Street. Flooding from high water levels has exposed this sewer in the past. In 2003, the Village of LeRoy placed approximately 400 LF of heavy stone riprap along the south bank of the creek to protect this sewer. In places, a thin fringe of tall emergent vegetation (*Sparganium eurycarpum*) has become established. Where this vegetation exists, it protects the bank against the prevailing winds, and cuts down on erosion. The land above this emergent fringe is mowed.

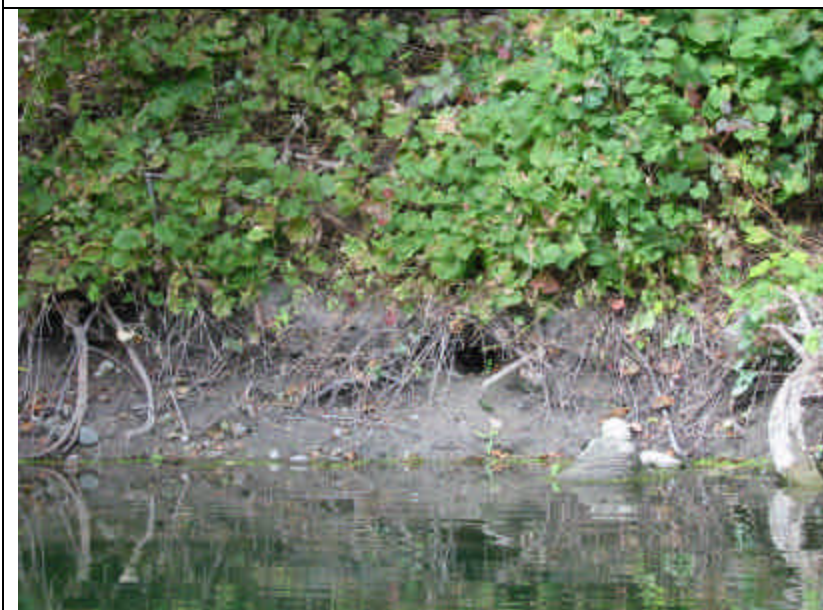
Photo 3. Bank conditions typical of north bank approximately 1500 feet east of Munson Street bridge. Note muskrat hole in bank just above water level.

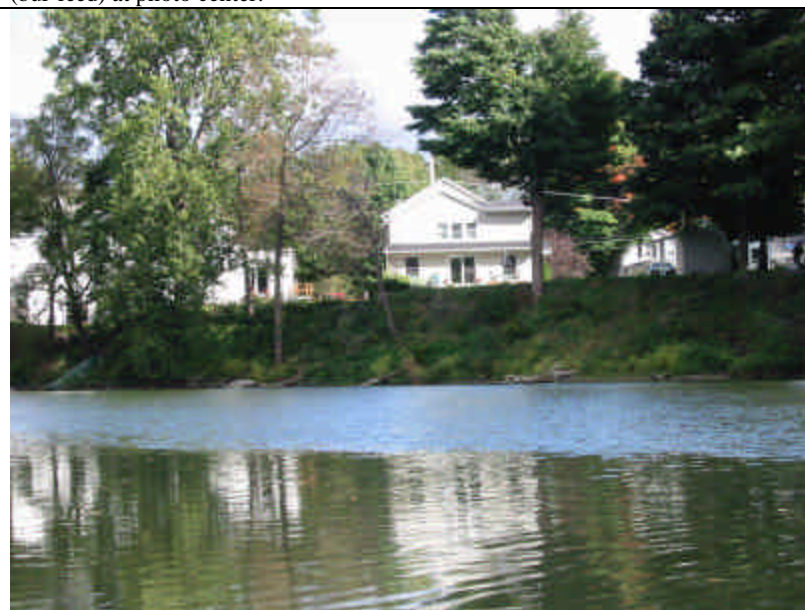
Photo 4. Typical bank conditions along south bank west of Rt. 19 bridge.

Some bank erosion is also evident along the south bank of the creek west of the Route 19 bridge. Erosion in this area is also caused by fluctuating water levels, and a lack of woody vegetation to hold the bank in place.
