**REFERENCE REACH** FIELD FORM  
**STREAM CHANNEL CLASSIFICATION LEVEL II**

STREAM NAME: Oatka Creek DRAINAGE AREA: 27 sq. miles BASIN NAME: Oatka

KENNEDY CONCEPTUAL DESIGN

STREAM RESTORATION STUDY AREAS

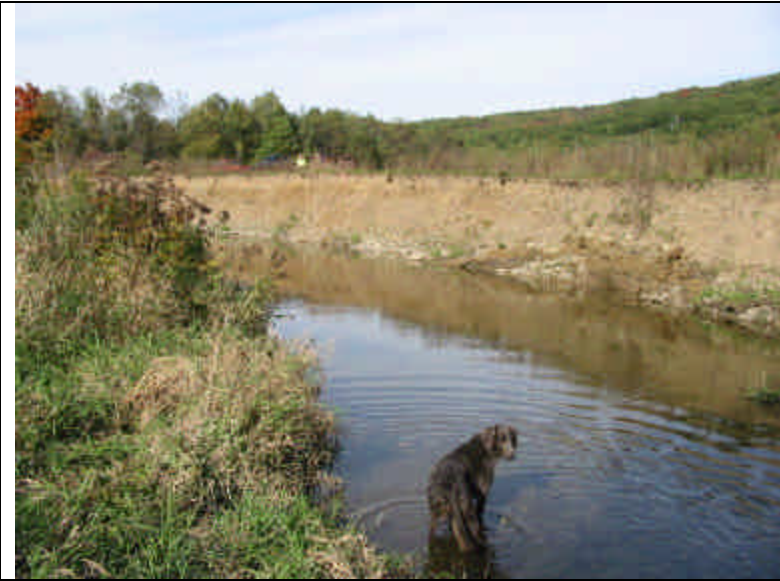
View of Oatka Creek exposed soil bank near Station 2+38, looking north.

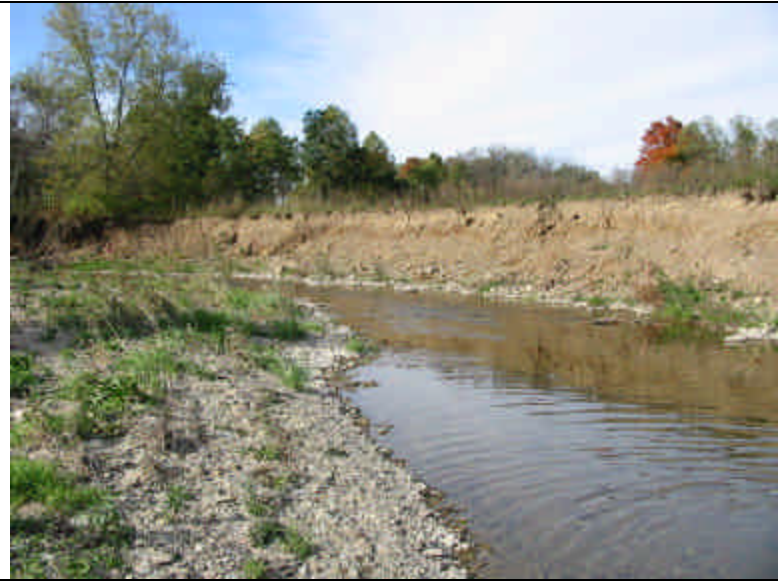
View exposed soil bank at Station 4+38, looking northeast.

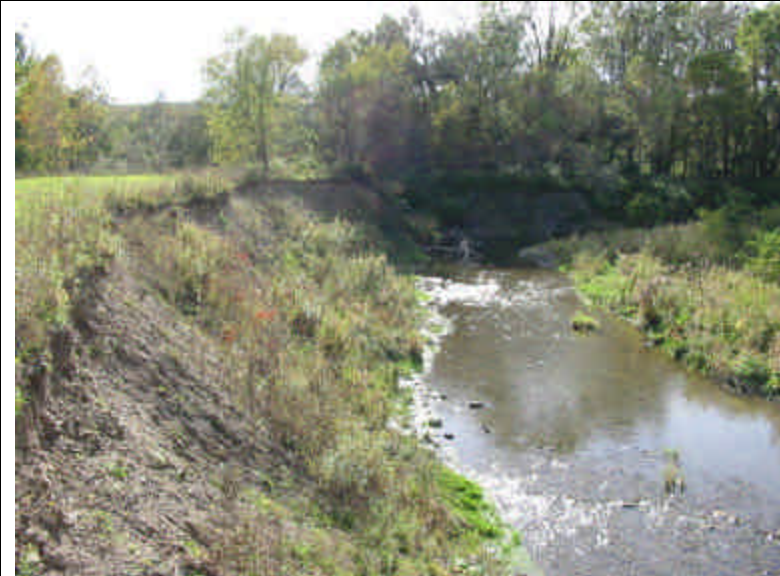
View of Oatka Creek exposed soil bank near Station A0+600, looking northwest along channel.

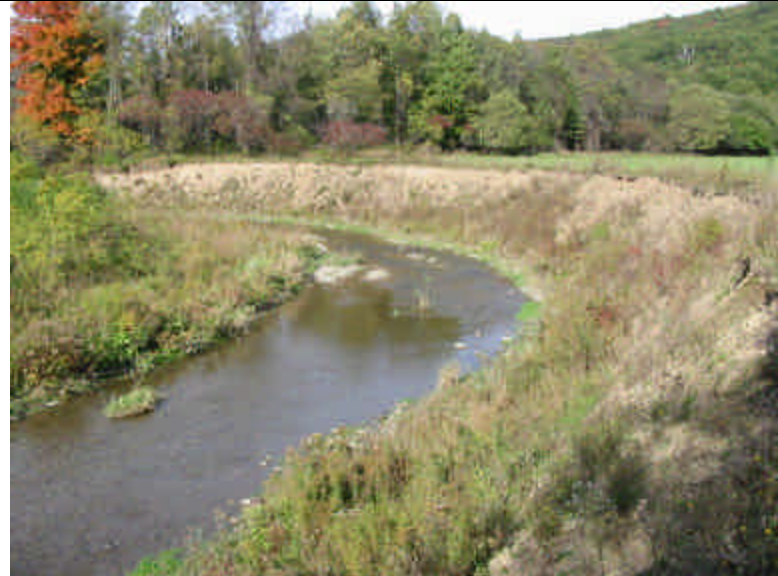
View of exposed soil bank at Station A0+800, looking northeast.
