REFERENCE REACH FIELD FORM
STREAM CHANNEL CLASSIFICATION LEVEL II

STREAM NAME: Black Creek DRAINAGE AREA: 22.7 square miles BASIN NAME: Genesee

BLACK CREEK NEAR MORGANVILLE ROAD

STREAM RESTORATION STUDY AREAS

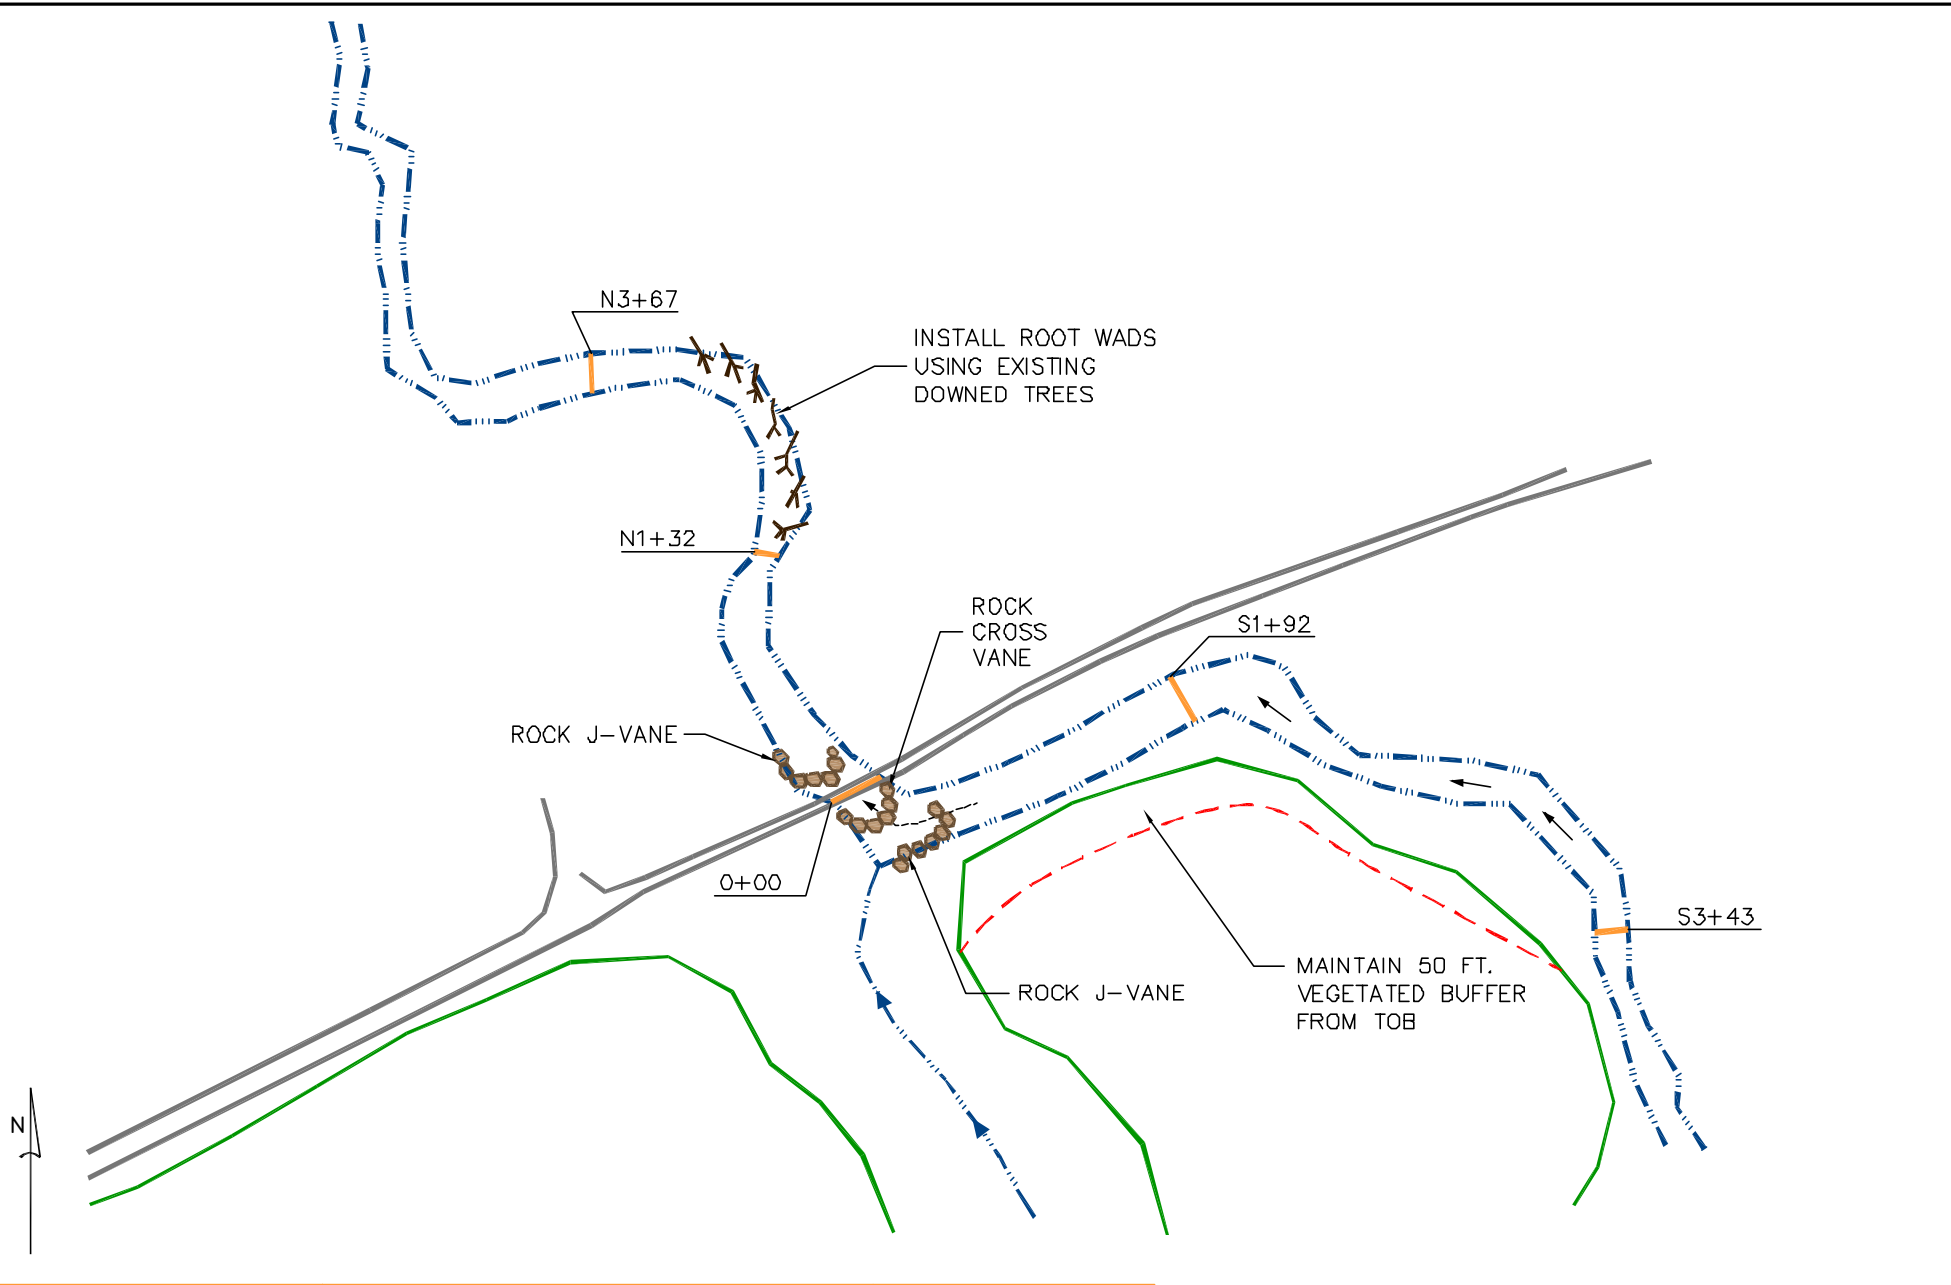
Statement of Problem: A large scour hole has formed at the northwest abutment of the bridge site. This scour hole may eventually undermine the bridge foundation, causing collapse of the structure. High flows also deposit large amounts of sediment in the channel and cause the formation of gravel bars. A thin line of riparian shrubs is located along the west bank of the creek. Although this vegetation provides some protection for the bank, the field is cultivated as close to the creek as possible, contributing soil erosion to the channel. Some evidence of channel degradation is seen in the formation of mid-channel bars downstream from the bridge site. Downed trees deflect currents into the banks, causing additional undercutting north of the bridge.

1. Construct a rock J-vane to deflect flow toward the middle of the channel, away from the northwest bridge abutment.
2. Encourage farmers and property owners to maintain at least a 50 ft. wide buffer of woody riparian vegetation along the channel.
3. Utilize deadfalls in the stream as root wads to stabilize failing banks.
