REFERENCE REACH FIELD FORM
STREAM CHANNEL CLASSIFICATION LEVEL II

STREAM NAME: Oatka Creek DRAINAGE AREA: 101.6 sq. miles BASIN NAME: Oatka

OATKA CREEK - SITE E006
CONCEPTUAL DESIGN
STREAM RESTORATION STUDY AREAS
P.N. 33502

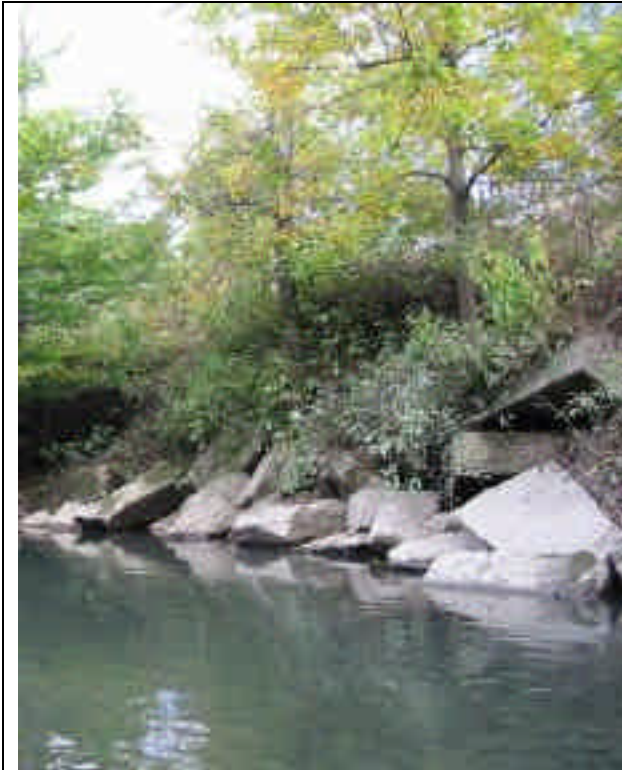
Photo 1. Detailed view of Rochester & Southern Railroad embankment adjacent to Oatka Creek south of Pavilion. Note placement of large concrete blocks, stones and rip rap to protect toe of slope.

1. Relocate approximately 250 linear feet of stream channel away from the Rochester & Southern Railroad embankment into an existing natural depression bypass channel, leaving the existing channel in place as an oxbow wetland. Deepen the natural depression to create a channel with a dimension and form that blends with the existing channel.
2. Utilize abundant on-site materials to create log vanes and root wads to stabilize the outside edges of existing and the new meander curve. Utilize rip rap reinforcement to stabilize the outside curve of the relocated stream channel. Place root wads and willow wattles in channel banks at strategic locations to protect exposed soil areas. Use large woody debris to direct flow in desired directions.
3. Utilize rock J-vanes to direct the channel flow away from exposed soil banks.

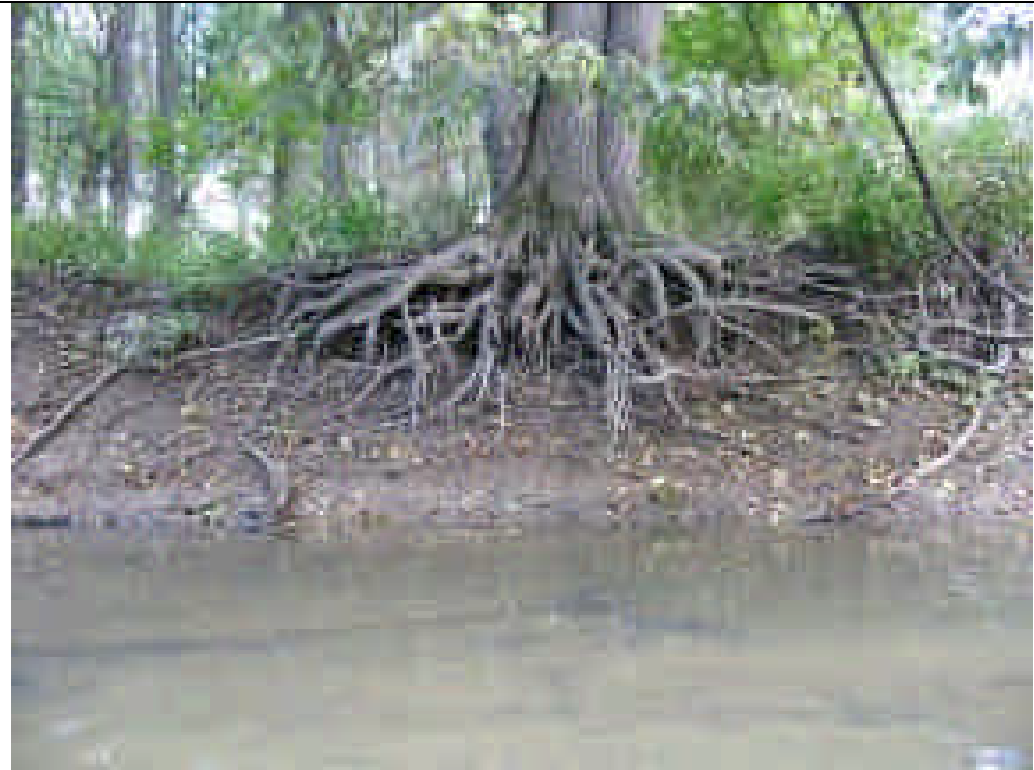
Photo 2. Detailed view of exposed roots on large silver maple tree on east bank of Oatka Creek at Pavilion. This condition is typical of many large trees along the bank. Located on the outside curve of a meander, the roots are undercut when the channel flows at bankfull. Frequent bankfull flow conditions exacerbate undercutting and cause trees to fall into the channel.

Portions of the channel banks are vertical or overhanging (Photo 2). Roots of large trees are exposed, and log jams were present at the sharp bends in the channel.

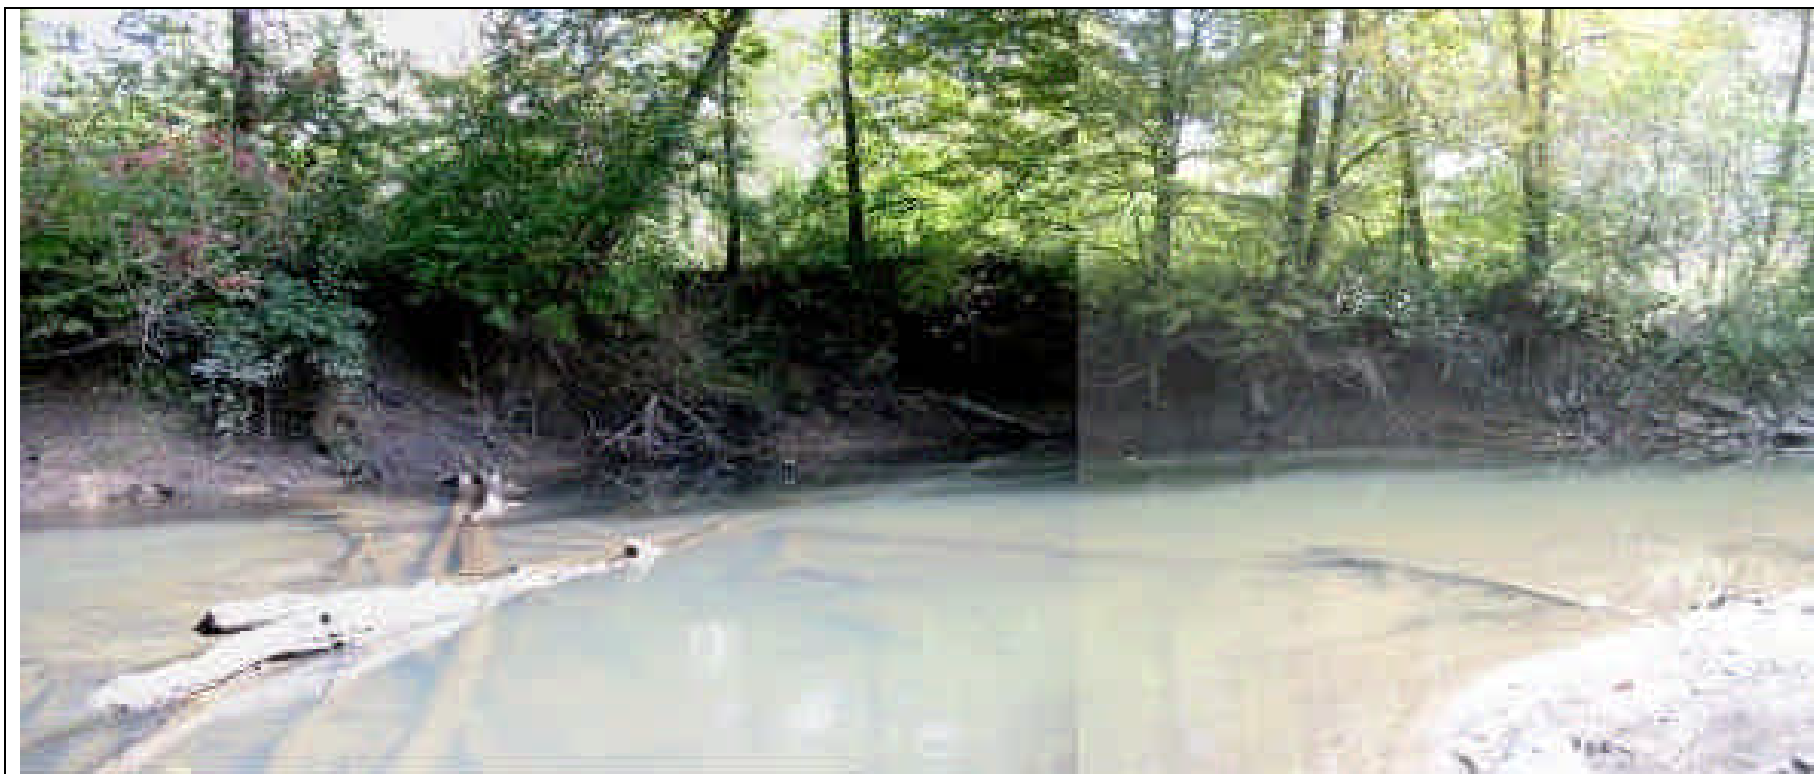
Photo 3. Panoramic view of exposed bank along outside edge of meander adjacent to Rochester & Southern Railroad tracks. Note the accumulation of large woody debris, high exposed soil banks.

Statement of Problem: This site was selected because the outside edge of the creek is located at the toe of the Rochester and Southern Railroad embankment. The railroad embankment has been damaged during previous flood events. Although large stone riprap has been placed at the toe of the slope to protect the embankment ballast, portions of the embankment are vulnerable to undercutting from the current. Erosion from this site was estimated at 0.395 tons of soil per year.

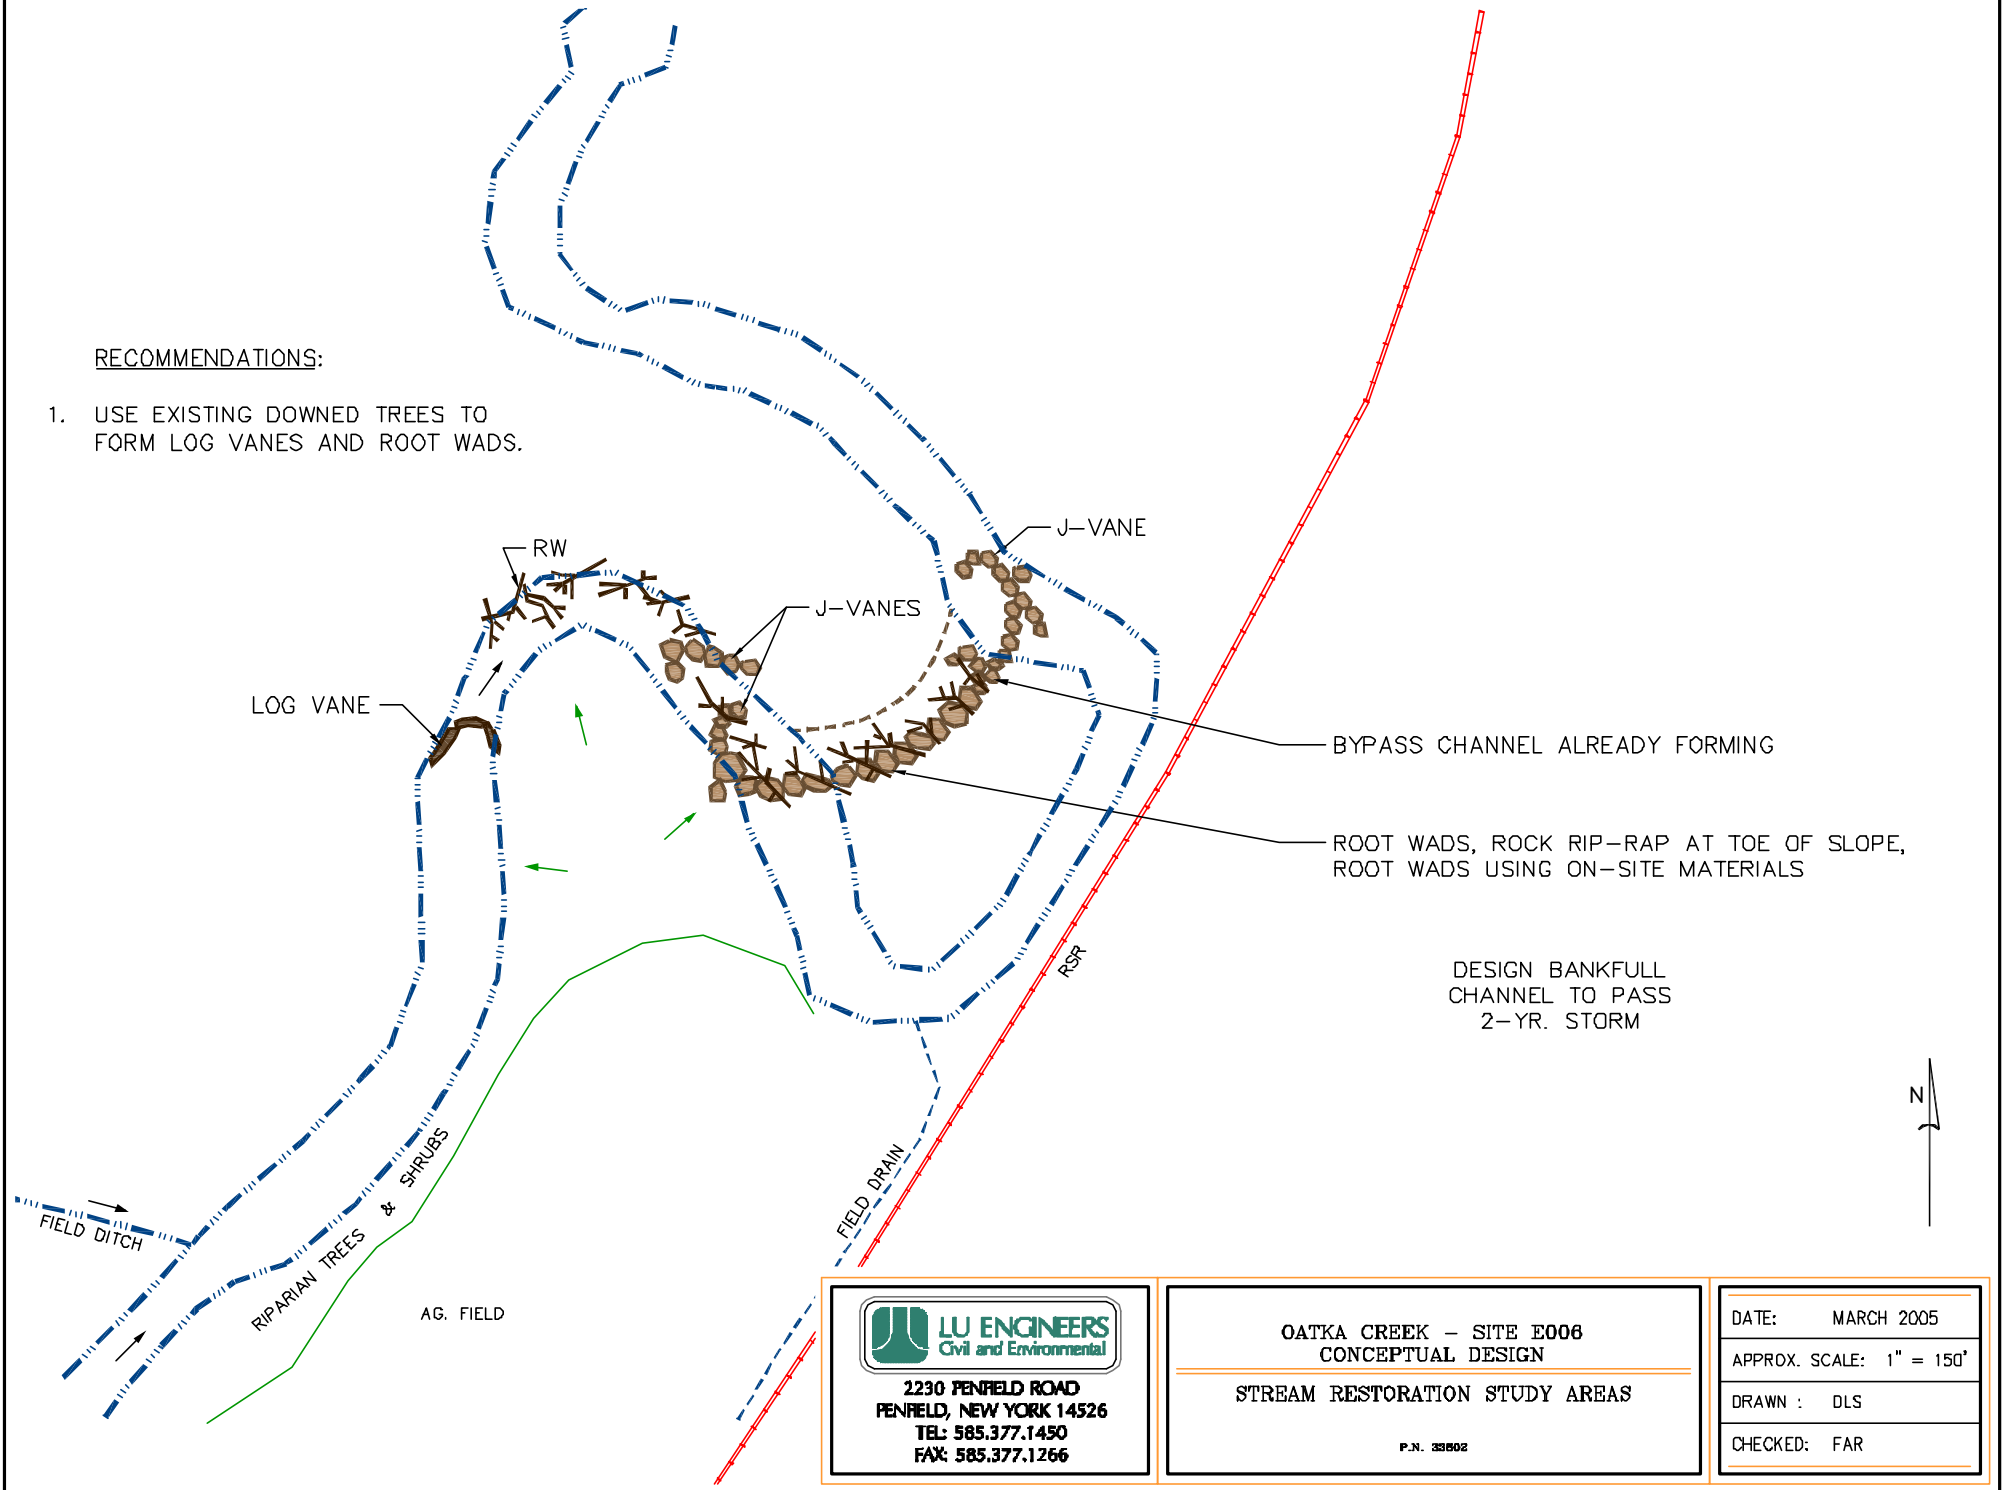
1. USE EXISTING DOWNED TREES TO FORM LOG VANES AND ROOT WADS.

4. Further survey and design will be required to determine appropriate morphology for the proposed channel. It is estimated that the new channel dimensions should be capable of passing approximately 900 cfs under bankfull conditions. This flow is estimated based on rough channel dimensions made during our limited site observation, channel width measurements from aerial photographs, and gradient measurements from U.S.G.S. topographic maps, and standard calculations. Channel cross section and profile survey and drainage calculations will be required for final design.
