REFERENCE REACH FIELD FORM
STREAM CHANNEL CLASSIFICATION LEVEL II

| STREAM NAME: <u>Oatka Creek</u> | | DRAINAGE AREA: <u>25.5 sq. mi.</u> | | BASIN NAME: <u>Oatka</u> | |
| LOCATION: <u>South of Martinsville Road, Town of Warsaw, Wyoming County, encompassing sites Oatm6 and Oatm7</u> | Latitude | Longitude | Mapped Soil Type(s) | K-factor(s) | |

MARTINSVILLE ROAD CONCEPT PLAN
 STREAM RESTORATION STUDY AREAS

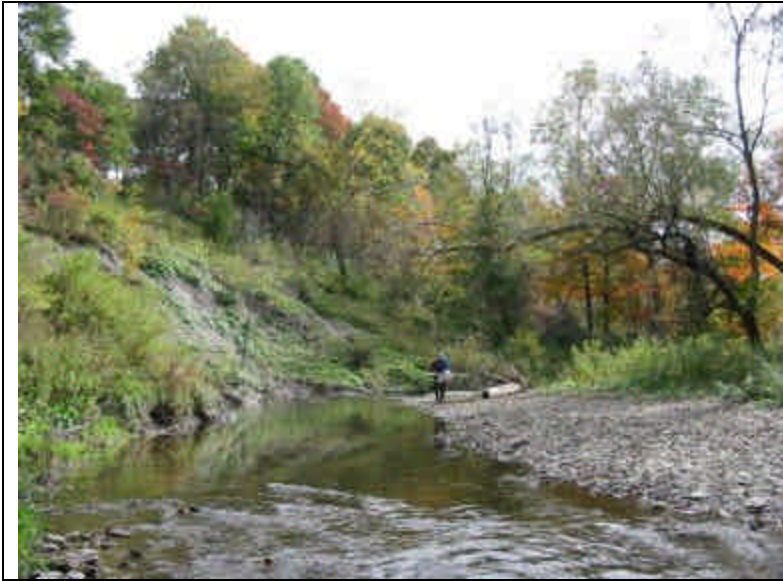
View of Oatka Creek at Martinsville Station N1+00 (approximately 400 feet south of Martinsville Road), looking south. Note high eroding bank at photo left.

- Place approximately 160 LF of large stone (24 in.+) rip rap along eastern toe of slope from Station N1+00 to Station S0+60. Use willow stakes along with riprap to stabilize bank toe of slope.
- Utilize existing downed trees in the channel to create rootwads and embed them in the banks to deflect current away from erodible banks.
- Construct rock J-vanes to direct flow away from slumping bank areas between Station S2+71 and Station S1+00.
- Place willow stakes on slumped areas above toe of slope.

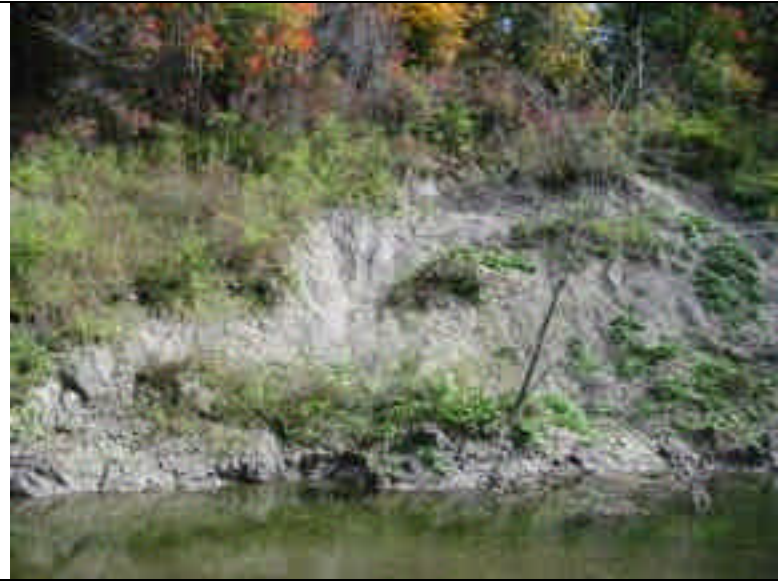
Detail of eroding bank in photo at left. Deep pool in stream channel undercuts clay bank, causing rotational slumping. Re-direction of channel flow away from this bank is needed to allow stabilization.

Statement of Problem: Site observation showed that influent streams contribute a high sediment load, resulting in the formation of mid-channel gravel bars, and divided thalwegs in the channel. Large trees have been undercut by high flows, and have fallen into the channel. Resulting log jams direct stream flow into steep, erodible, clay banks on the east side of the channel. Undercutting has caused slumping from Station N1+00 to approximately S0+60.

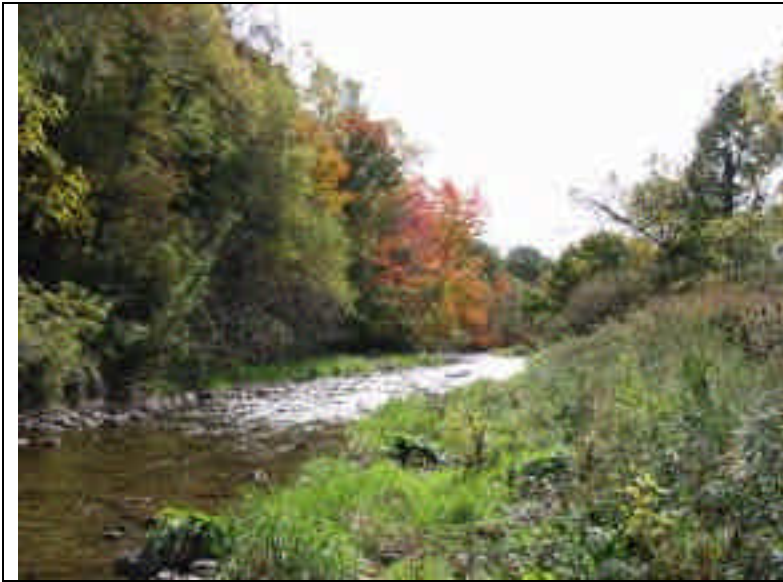
Oatka Creek at Martinsville, 1000 feet south of Martinsville Road, looking south. Note well vegetated channel banks and good condition of channel.

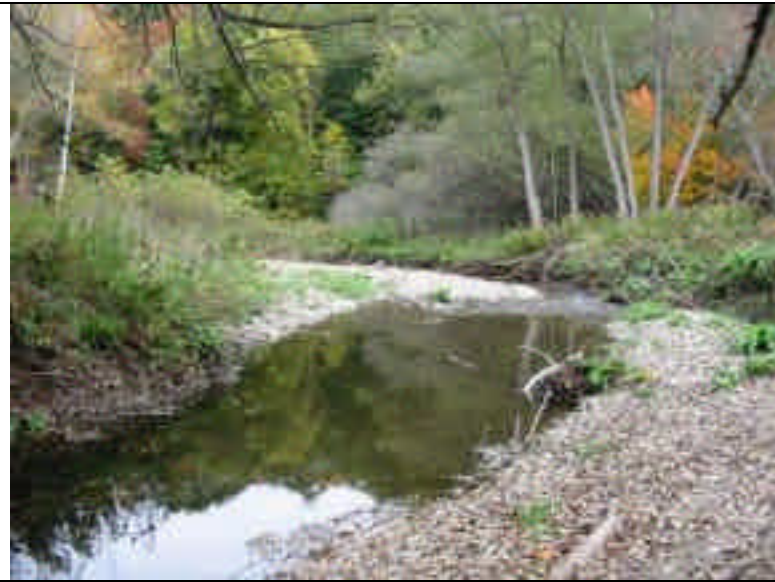
Oatka Creek, approximately 800 feet south of Martinsville Road. Influent stream channel at photo right deposits large amounts of gravel, causing channel to meander.
