## **CHAPTER 7. SOURCES OF POLLUTION**

### **G. ROADBANK EROSION**

Potential Pollution Problems By Sub-Watershed  
Roadbank Erosion - Overall Ranking

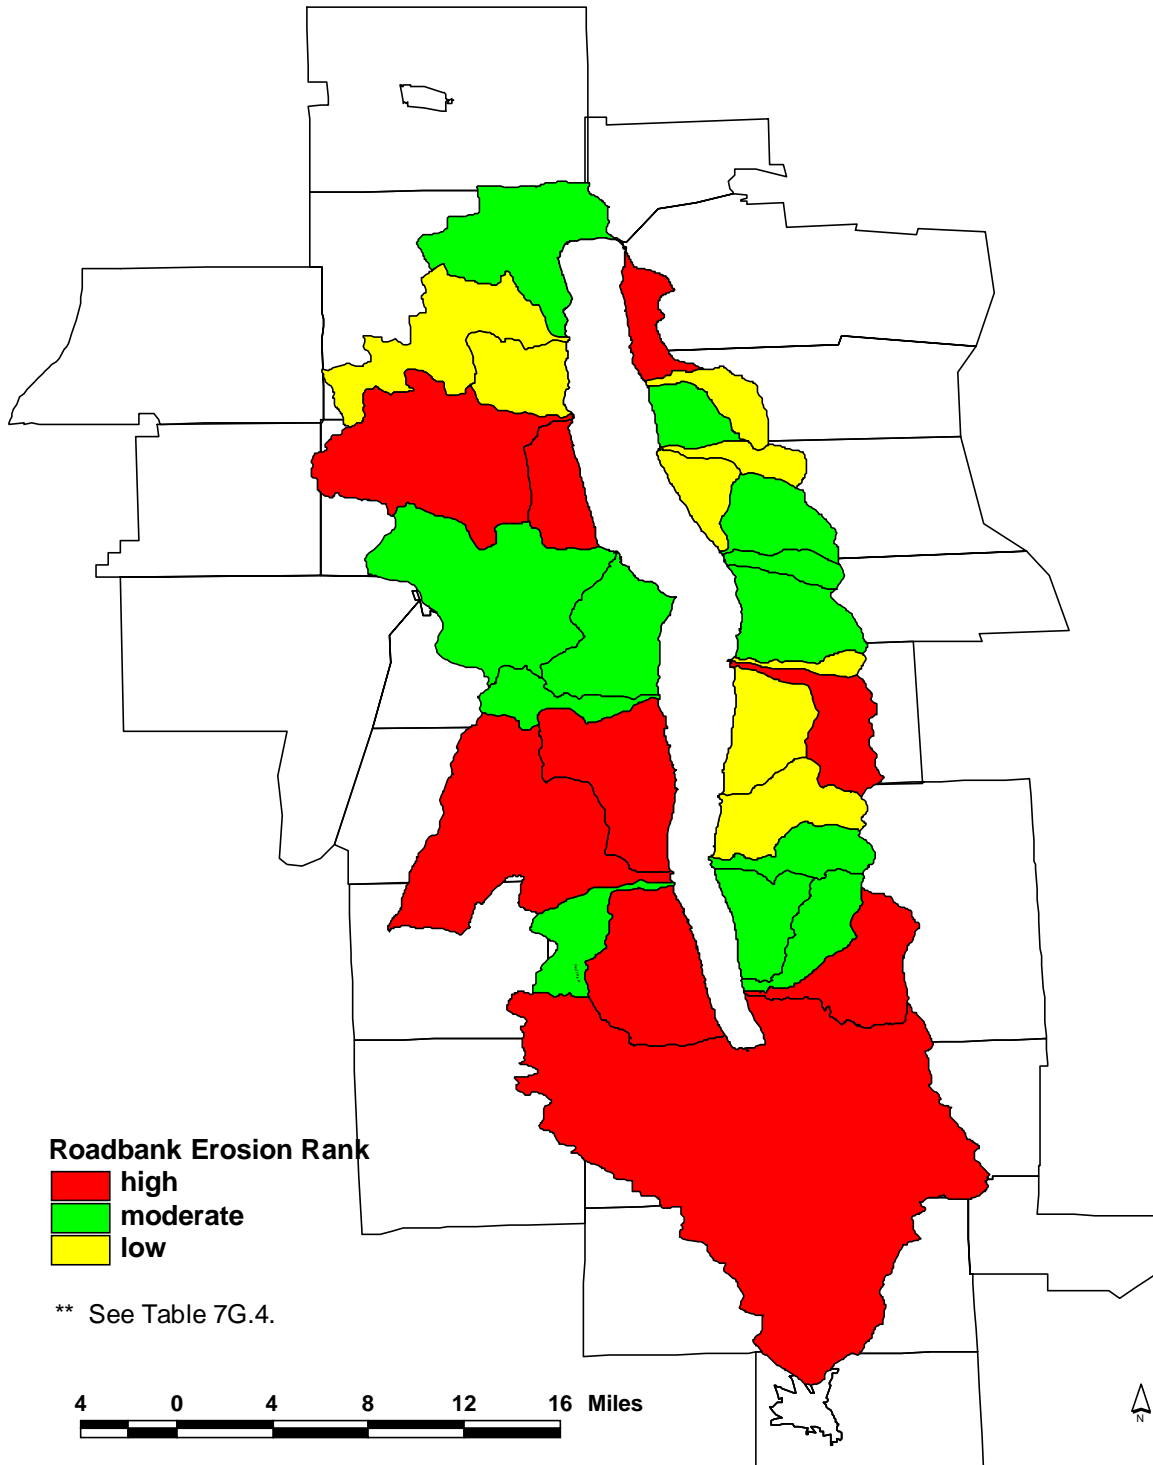
Sub-watershed and direct drainage rankings were determined by comparing the miles of very severe and severe erosion, total tons of erosion per year and tons of erosion per mile (*Table 7G.3.*). These overall erosion values indicate the severity of potential sediment erosion from roadbanks within the Seneca Lake watershed. The overall ratings of the sub-watersheds are listed in Table 7G.4. and illustrated in Figure 7G.1.

Table 7G.4 lists the sub-watersheds roadbank erosion pollution from highest to lowest.

**High** potential for roadbank erosion:

Sub-watersheds and Direct Drainage's: Big Stream, Catharine Creek, Hector Falls Creek, Kashong Creek and Mill Creek, Benton DD, Reading DD, Starkey DD and Sunset Bay DD

**Moderate** potential for roadbank erosion

Sub-watersheds and Direct Drainage's: Glen Eldridge, Indian Creek, Keuka Lake Outlet, Rock Stream, Sawmill/Bullhorn Creek, Simpson Creek, Geneva DD, Long Point DD, Plum Point Creek, Satterly Hill, Sixteen Falls Creek DD and Wilcox Creek DD

**Low** potential for roadbank erosion

Sub-watersheds and Direct Drainage's: Kendaia Creek, Lodi Point, Reeder Creek, Lamoreaux Landing DD, Reed Point DD, Sampson State Park DD, Wilson Creek and Valois DD
