**REFERENCE REACH** FIELD FORM  
**STREAM CHANNEL CLASSIFICATION LEVEL II**

STREAM NAME: Oatka Creek DRAINAGE AREA: 27 sq. miles BASIN NAME: Oatka

KENNEDY CONCEPTUAL DESIGN

STREAM RESTORATION STUDY AREAS

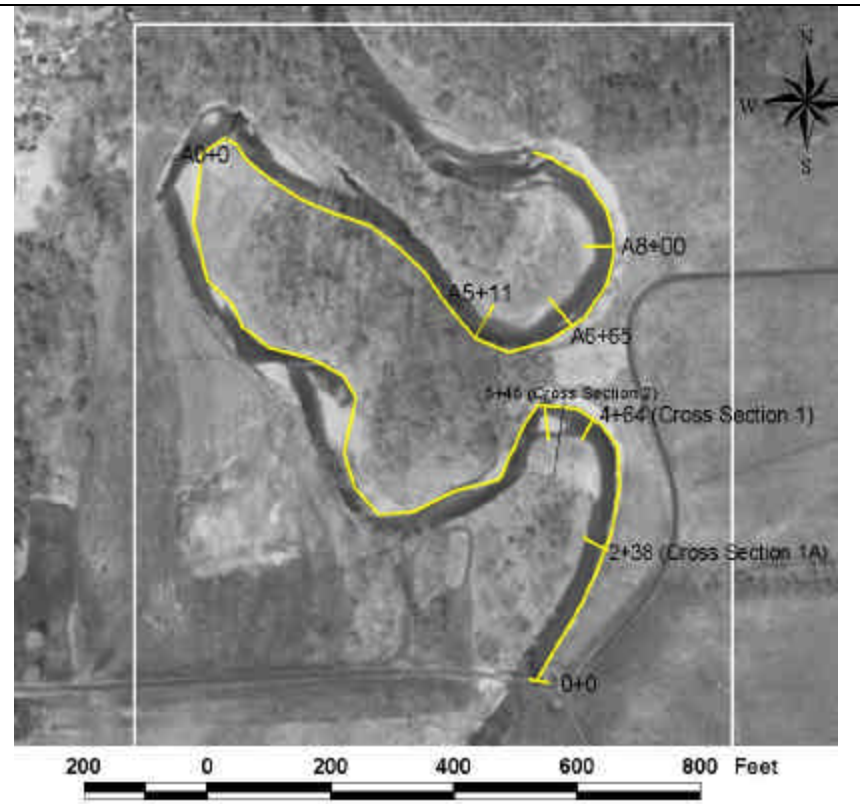
2002 Aerial Photograph, Oatm 9-Kennedy Site with Longitudinal Profile Stationing

The stream channel gradient decreases markedly over the length of the reach, from 0.0065 to 0.0026. The significance of this gradient drop is that the current slows, and particulates tend to settle out in slower-moving stream sections. Several areas with extremely high banks were observed. The linear distances of these exposed soil banks is shown in the aerial photograph. Sloughing and slumping of the banks is common.
